Manhole Inspection Summary

Manhole # S25EE1044MH

Insp Date: **1/24/07 2:26 PM**

Location Address: **3737 FALLS RD**

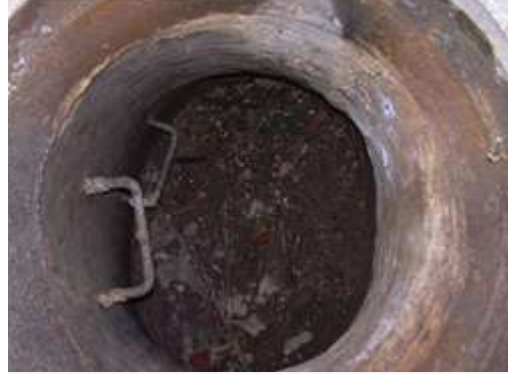
Top View

Channel debris

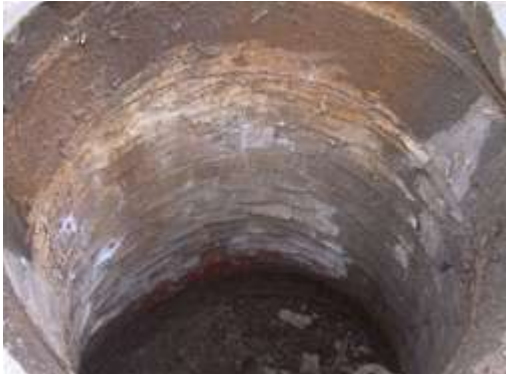
Defect

☒ **Leaks**

Infiltration: ☐ None ☒ **Joint** ☐ Cracks ☐ Mortar ☐ Roots ☐ Wall

Condition: ☐ Sound ☐ Cracked ☐ Root Intrusion ☐ Loose Brick ☒ **Deteriorated**

Infiltration: ☐ None ☐ Joint ☐ Cracks ☒ **Mortar** ☐ Roots ☒ **Wall**

Frame leaks. Adjustment and Barrel infiltration - other side.

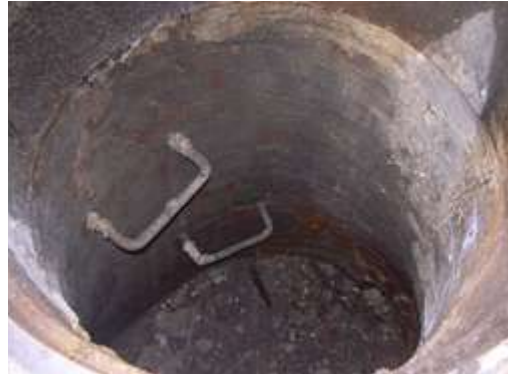
Defect

Frame leaks. Adjustment infiltration.

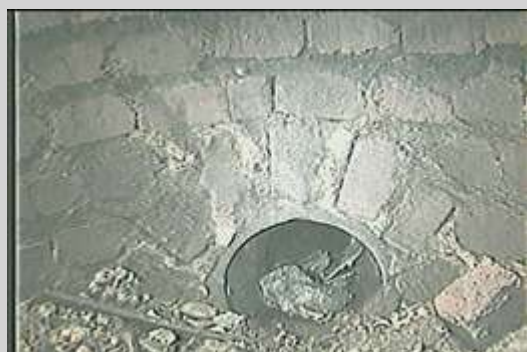
Pipe Out @ 12 O'Clock

8 in. Circular Gravity Sewer

Deposits: ☐ None ☒ **Mud** ☐ Sludge ☒ **Debris** ☐ Grease

Deposits Extent: **Light**

Infiltration: **Evidence**
